Quantifying Riverbank Erosion Based on Morphology: Case Study of Bernam River

¹School of Civil Engineering, Universiti Teknologi MARA, 40450 Shah Alam, Selangor, Malaysia.

Abstract: Erosion of riverbanks has far-reaching consequences, including changes to river shape and local habitat, destruction of riparian land, harm to buildings and other infrastructure, and a weakened capacity to withstand floods. The determination of which areas of a riverbank are susceptible to erosion is a crucial step in being able to forecast changes in the river's course and aid with stream management and restoration. This study assessed the magnitude of streambank erosion at three different channel morphologies which are straight, mild bend and extreme curve channel. The purpose of this research is to conduct fieldwork erosion monitoring of riverbanks, including those affecting hydraulic characteristic, bank geometry and soil properties. This is done so that the extent of riverbank erosion that occurs at natural rivers because of land use at locations upstream of the river. Erosion monitoring data provide measurements of erosion depth and riverbank cross-profiling across different channel morphologies

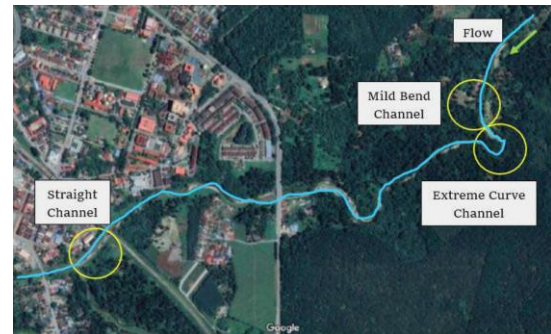
Fig 2: Site location for study area

river. In this study, research is carried out at three different channel morphologies of the river. These morphologies of the river are referred to as a straight river, a mild bend, and an extreme curve. The site location for all channel morphology as shown in Fig. 2.

The research area for the assessment of riverbank erosion is the Bernam River, which acts as a natural barrier between the Malaysian states of Perak and Selangor that located at latitude $3^{\circ}51.02$ N and longitude $100^{\circ}50.15$ E. The Bernam River basin covers an area that is 2836.33 km^2 in total. It flows from the upstream of Mount Triang Timur, which is situated to the east of Mount Titiwangsa, and continues all the way to the Straits of Malacca, which is located to the west. In the upper part of the basin, vegetation covers such tropical hill rainforests, oil palm trees, and rubber trees dominate. The Bernam River is one of the rivers whose banks are susceptible to erosion, transport and deposition as a result of the land usage along the bank and the deforestation that has occurred upstream of the

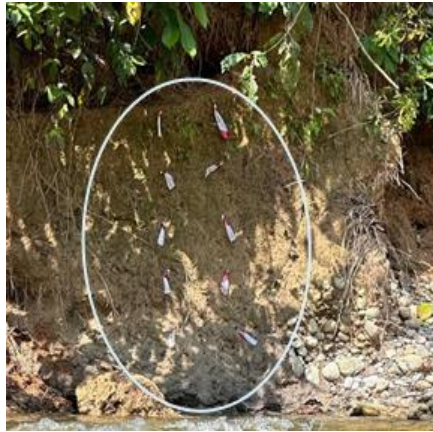
Fig. 3: Erosion pins installed subjected to extreme curve channel after 30 days of installation

Measurements taken in the field of the river include the riverbank erosion rate, the hydraulics characteristics, the bank geometry, and the soil parameters. In accordance with Lawler's (1993) recommendations, the erosion pin method is utilized in order to determine the magnitude at which the riverbank is being eroded. The location for erosion pin transects determined according to the critical of the bank erosion. 10 pins were installed at each channel morphology with a total of 30 pins used in this study. According to Mohd Rosli et al., (2021), the length of the pins is determined by the estimated rates of erosion as well as the number of times that the location is visited. The total length of the pins is 35 cm and 6 mm diameter of mild steel and placed perpendicular to the bank until 30 cm of the pin are placed in the riverbank with the spacing 30 cm between each pin as illustrated in Figure 3.

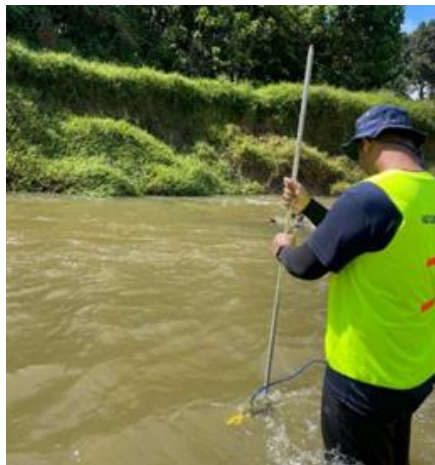
Fig. 4: Wading technique using Current Flow Meter

A gauging method that is consistent with the Drainage and Irrigation Department's Hydrological Procedure No. 15 (1976), reprinted (1995) has provided a recommended guideline for wading technique as demonstrated in Figure 4. For measuring stream depth, d , between 0.25 m and 1 m, a measurement of $0.6d$ from the water surface is appropriate, whereas for measuring depth, d , between 1 m and 1.5 m, a reading between $0.2d$ and $0.8d$ from the water surface is suggested. For this study, the current flow meter for river is used to take the reading of the river velocity. This research employs the measurement of near-bank velocity in a manner similar to Saadon et al. (2021), which was adapted from Hasegawa (1989). In this approach, near-bank velocity is measured at a horizontal distance of 1 meter from the eroded bank, rather than using the stream-averaged velocity (u), to better assess its role in regulating bank erosion or accretion.

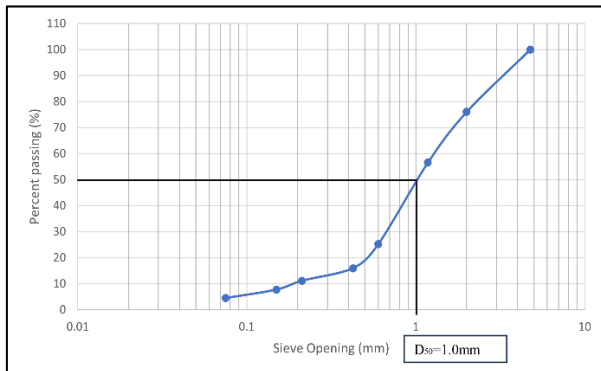
Fig. 5: Particle size distribution for straight channel morphology

morphologies which are straight, mild bend and extreme curve of river. The characteristics of the soil are indicative of the soil composition that existed along the riverside. The experiment was carried out using a test known as a sieve analysis, in which a sample of soil is dried for 24 hours and then weighing it before being placed in a sieve shaker. The purpose of the experiment was to determine the mean particle size at the D_{50} . For straight channel, a sample of 1,000 g of soil at riverbank are taken for the sieving. As a result, the particles that could be found in each sieve were measured and recorded. Following completion of the sieve analysis test, the particle size distribution is depicted in Fig. 6 below. The mean particle size at D_{50} is 1.00 mm, which is classified as very coarse sand. For the mild bend channel morphology, a sample weighed 1,500 g were placed into the sieve. After sieving in the mechanical shaker for 10 minutes, the particles retained in each sieve were measured and recorded. The graph of the particle size distribution that was produced after carrying out the sieve analysis test may be found in Fig. 5. The average particulate size at D_{50} is 2.5 mm, which classifies the material as gravelly sand soil. A 1,000 g sample was weighed and placed in the sieve to represent particle size of the extreme curve channel morphology. Following the sieving process that took place in the mechanical shaker for 10 minutes, the particles that were retained in each sieve were measured and documented. Fig. 7 displays the graph of the particle size distribution that was obtained as a result of carrying out the sieve analysis test. The particle size for extreme curve bank is a coarse sand since the average particle size at D_{50} is 0.95 mm.

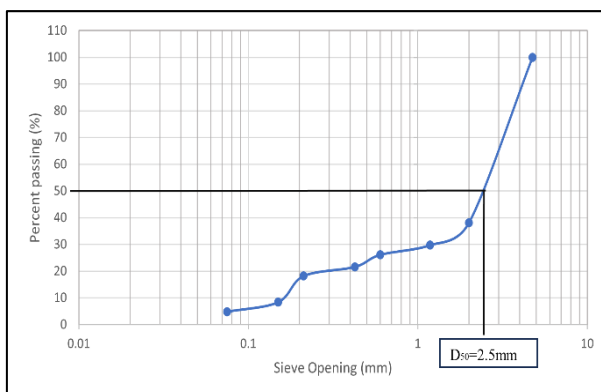
Fig. 6: Particle size distribution for mild bend channel morphology

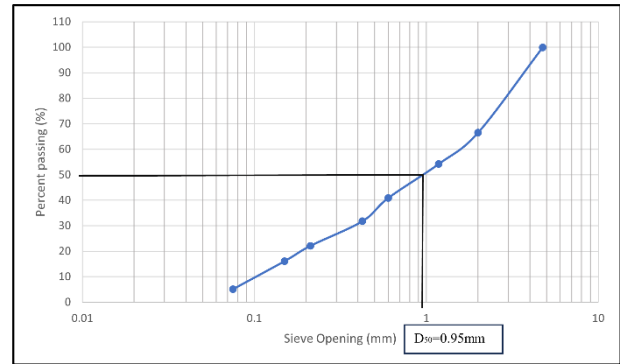
Fig. 7: Particle size distribution for extreme curve channel morphology

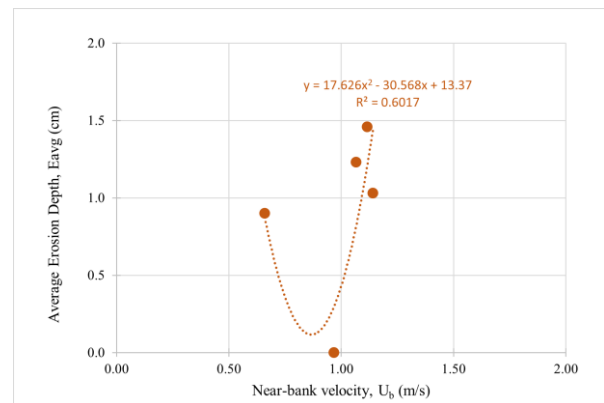
Fig. 9: Erosion depth and near bank velocity relationship for mild bend channel at Bernam River using polynomial function

It was determined that there is a correlation between depth of erosion and velocity near the bank through a polynomial function. Fig. 8 to 10 illustrate the relationship between rate of erosion and near bank velocity. It has been found that the polynomial function provides an excellent correlation for different types of channel morphology. The equation derived from these functional relationships then can be used to develop the erosion rate relationship for other rivers with the same type of morphology

The R^2 value for straight channel has the best correlation between the variable of the average erosion depth and near bank velocity at $R^2 = 0.9837$ for polynomial function. The strong correlation value, $R^2 = 0.9235$, is also given by the polynomial function for the extreme curve channel. Furthermore, the correlation for the mild bend channel indicates a moderate relationship, with an R^2 value of 0.6017, as presented in Table 5. In this correlation, y represents the average erosion depth (cm), while x denotes the near-bank velocity (U_b) in m/s.

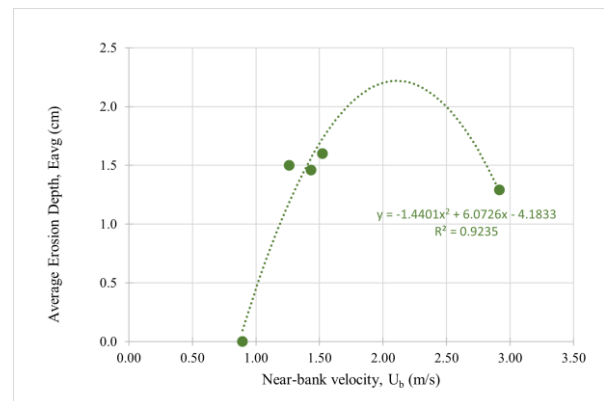
Fig. 10: Erosion depth and near bank velocity relationship for extreme curve channel at Bernam River using polynomial function
